The Secretary of the Interior's Standards  
for the Treatment of Historic Properties

with Guidelines for  
Preserving, Rehabilitating  
Restoring & Reconstructing  
Historic Buildings

Kay D. Weeks and Anne E. Grimmer

U.S. Department of the Interior  
National Park Service  
Cultural Resource Stewardship and Partnerships  
Heritage Preservation Services  
Washington, D.C.  
1995

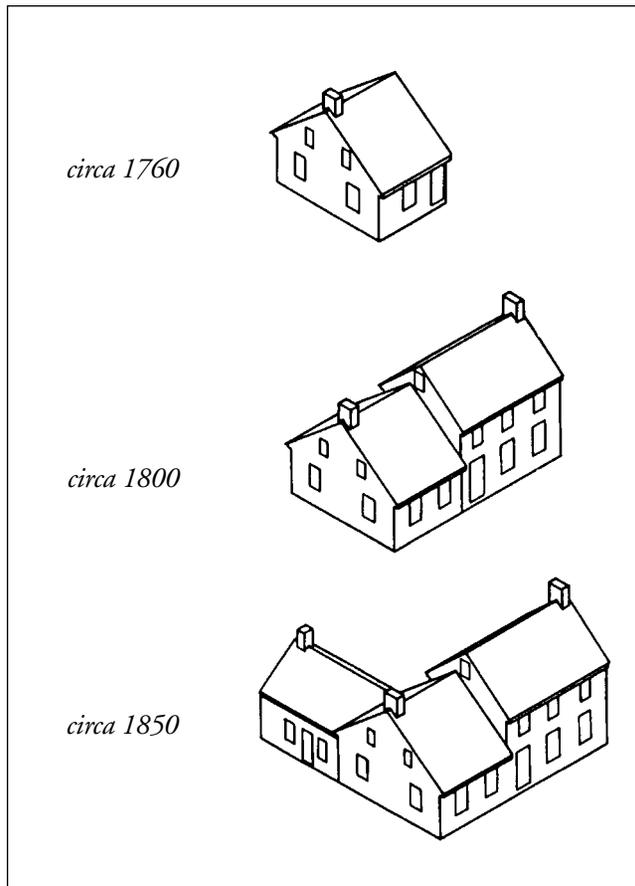
*This three-part drawing shows the evolution of a farm house over time. Such change is part of the history of the place and is respected within the treatment, Preservation. Drawing: Center for Historic Architecture and Engineering, University of Delaware (adapted from Preservation Brief 35: Understanding Old Buildings).*

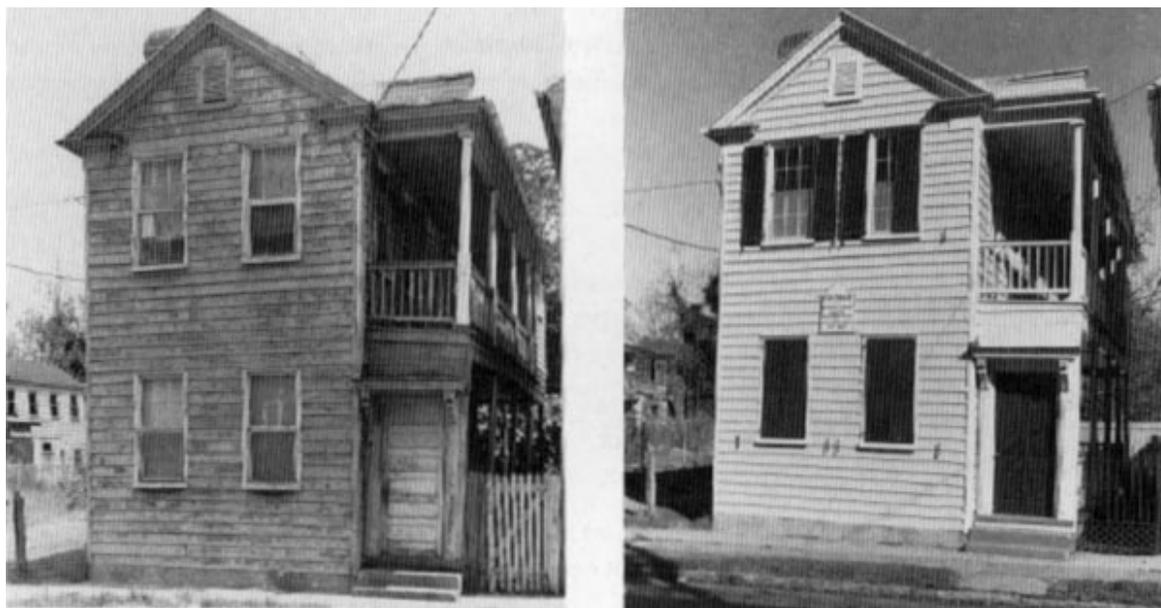
*Maximizing retention of historic materials and features is the primary goal of Preservation as demonstrated here in these “before” and “after” photographs. Aside from some minor repairs and limited replacement of deteriorated material, work on this house consisted primarily of repainting the wood exterior. Photos: Historic Charleston Foundation.*

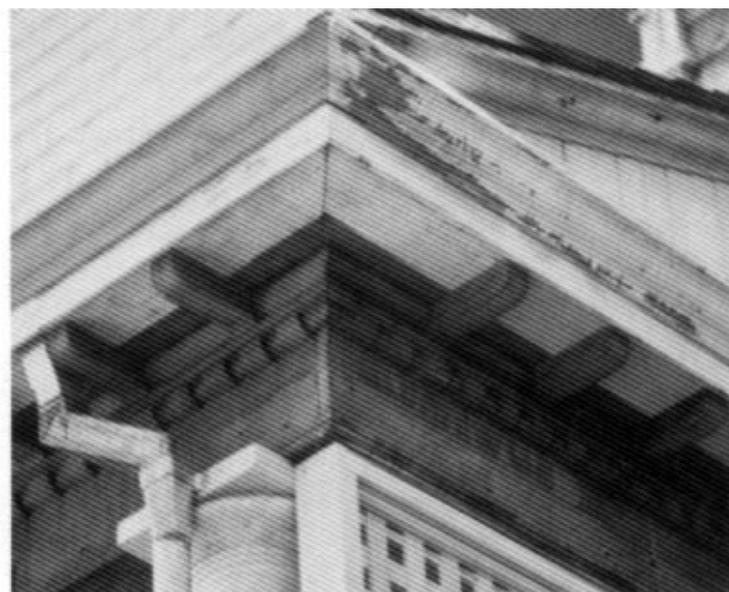
*Two examples of “limited replacement in kind” point out an appropriate scope of work within the treatment, Preservation. (a) One metal modillion that has sustained damage from a faulty gutter will need to be replaced; and (b) targeted repairs to deteriorated wood cornice elements (fascia board and modillions) meant that most of the historic materials were retained in the work.*

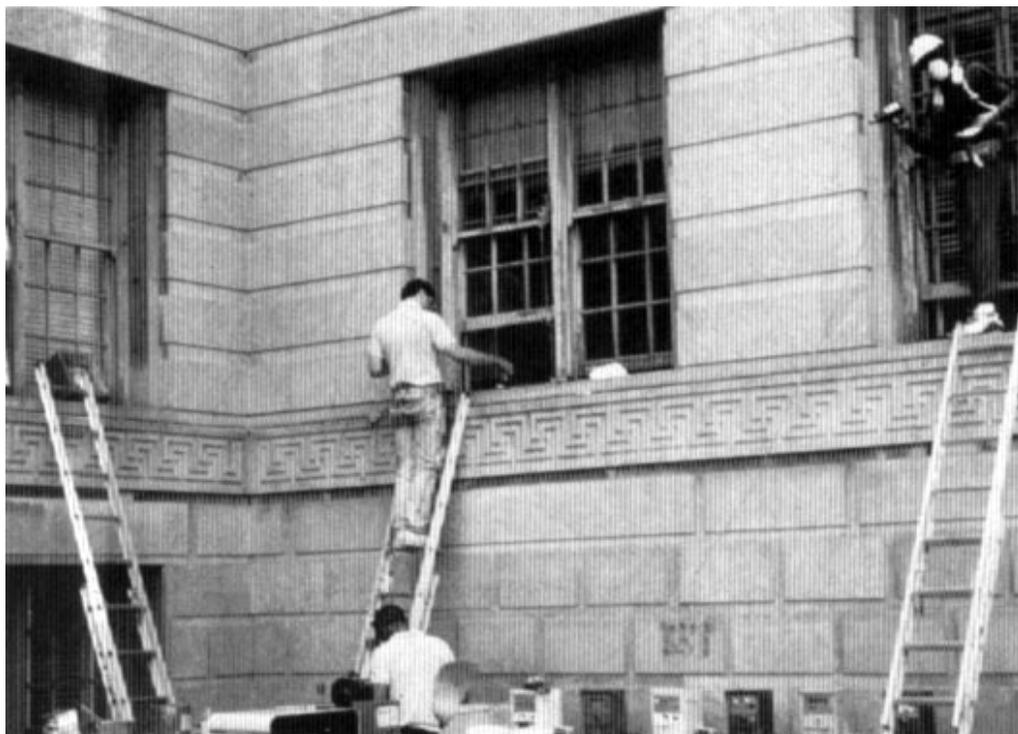
*Preserving a building's historic windows generally involves scraping, sanding, and re-painting. While some repair work will most likely be undertaken within the scope of work on this institutional building, replacement of the window units is usually not an appropriate Preservation treatment. Photo: Chuck Fisher.*

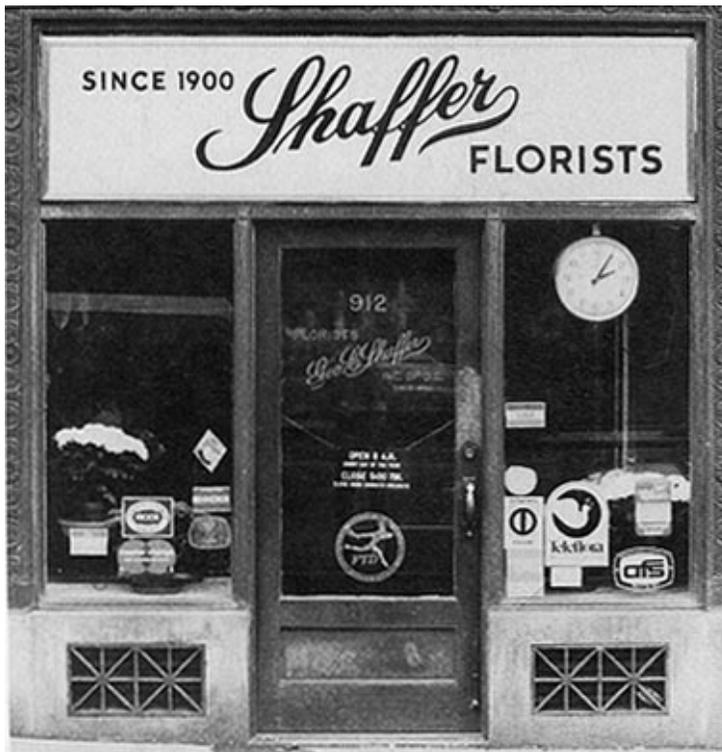
*The original form and features of this 1920s storefront have been retained through Preservation. Photo: David W. Look, AIA.*

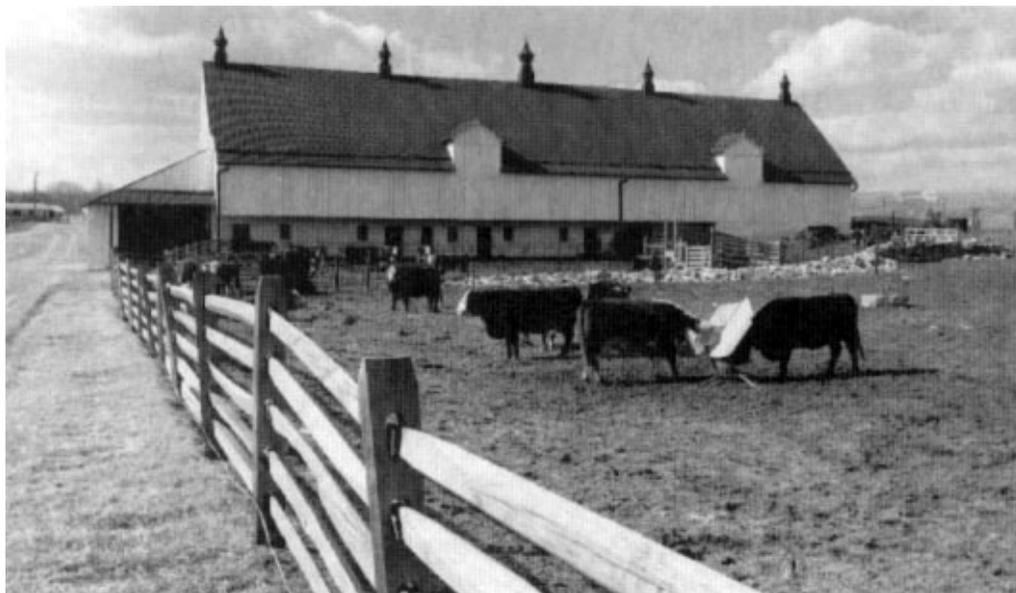
*The goal of Preservation is to retain the historic form, materials, and features of the building and its site as they have changed—or evolved—over time. This bank barn was built in the 1820s, then enlarged in 1898 and again in 1914. Today, it continues its role as a working farm structure as a result of sensitive preservation work. This included foundation re-grading; a new gutter system; structural strengthening; and replacement of a severely deteriorated metal roof. Photo: Jack E. Boucher, HABS.*

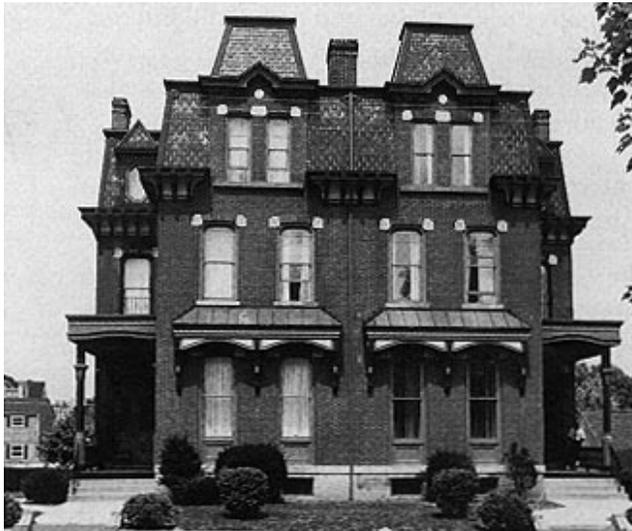
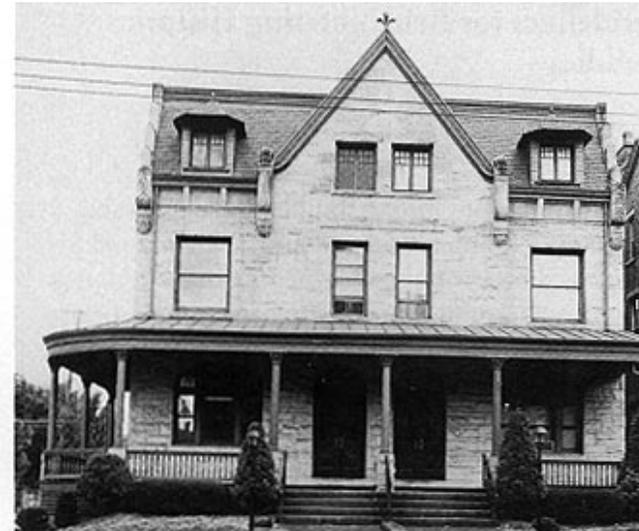
*Originally built as single-family, semi-detached duplexes, these houses were rehabilitated for a new use as rental apartments. While some alteration to non-significant interior features and spaces was necessary in each one, the exteriors were essentially preserved. Photos: Mistick, Inc.*

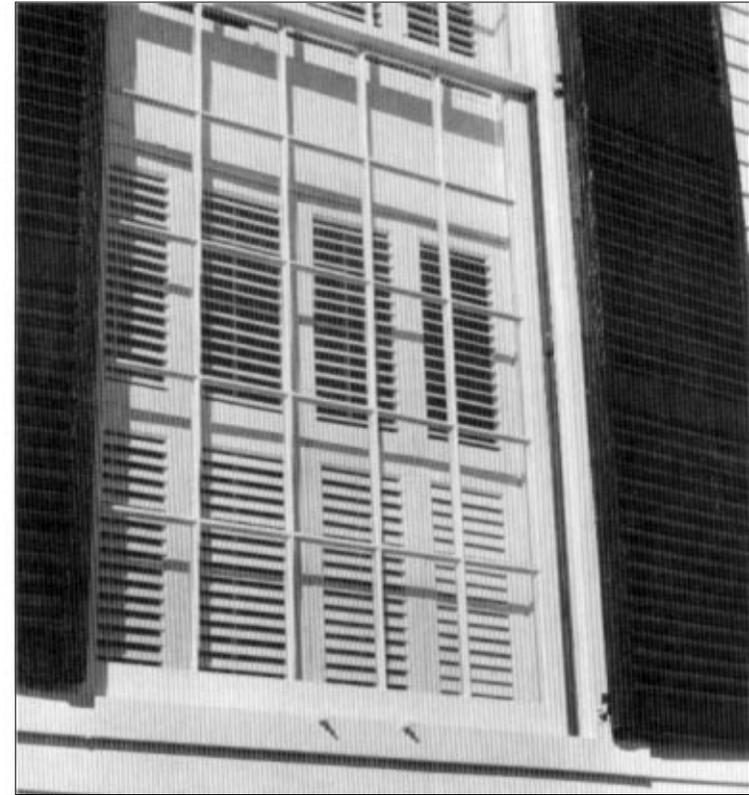
*According to the Standards for Rehabilitation, existing historic materials should be protected, maintained and repaired. In an exemplary project, the windows and shutters of this historic residence were carefully preserved.*

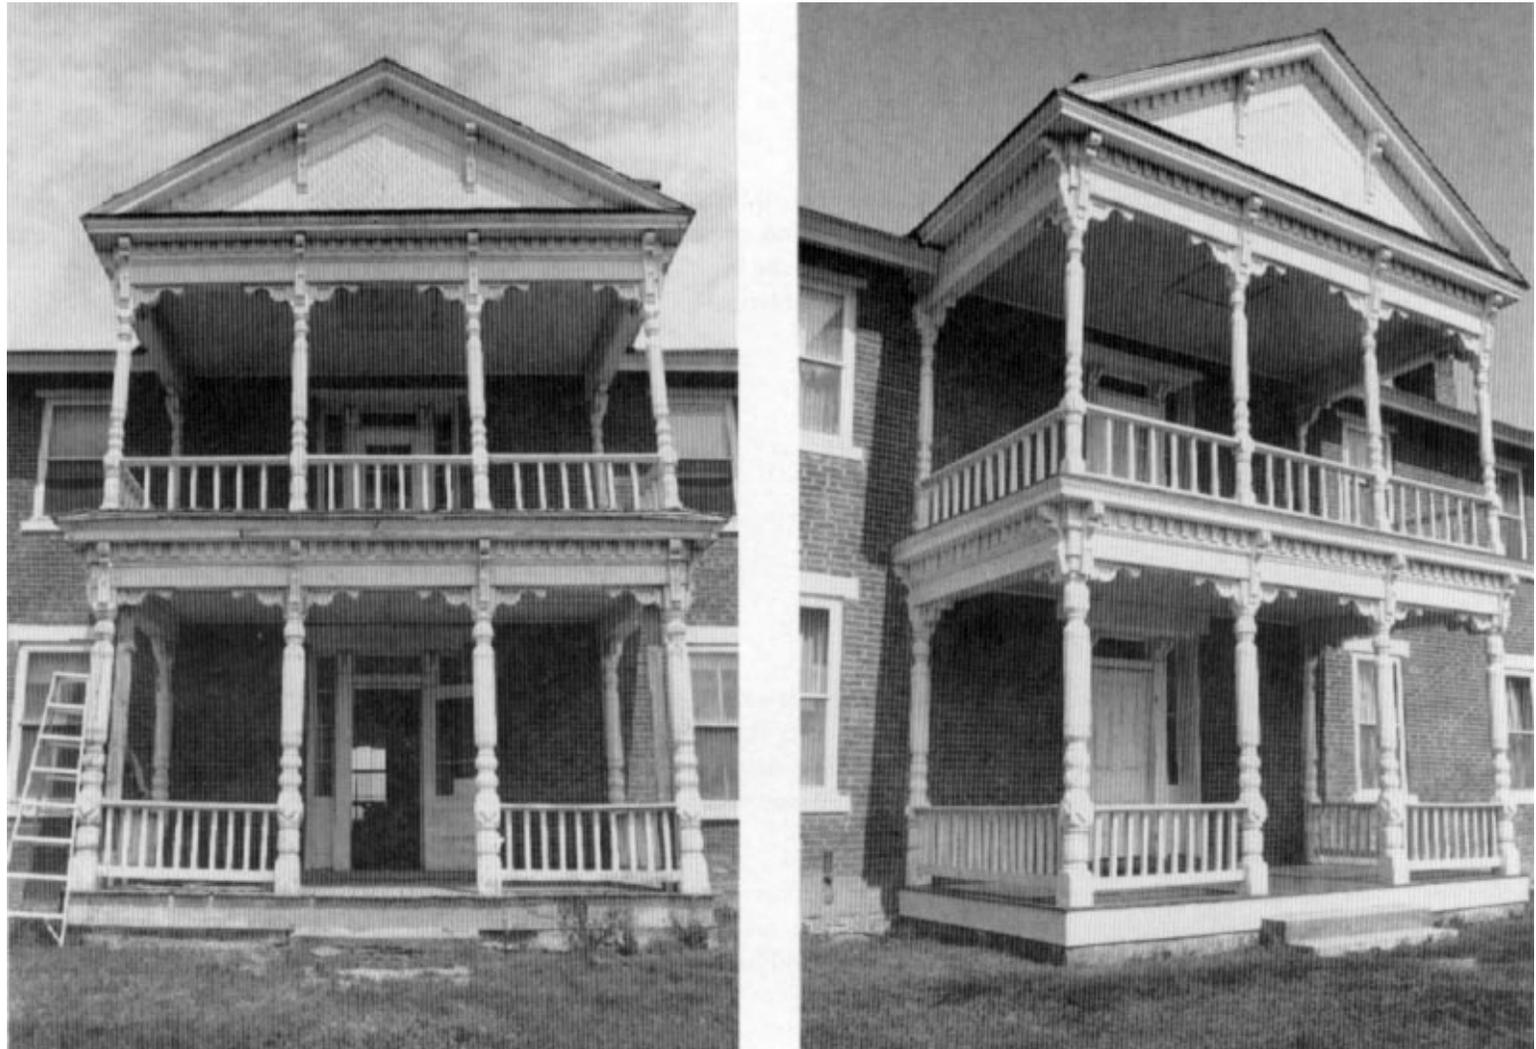
*In Rehabilitation, deteriorated features should be repaired, whenever possible, and replaced when the severity of the damage makes it necessary. Here, a two-story porch is seen prior to treatment (left). The floor boards are rotted out and the columns are in a state of collapse, supported only by crude, temporary shafts. Other components are in varying stages of decay. Appropriate work on the historic porch (right) included repairs to the porch rails; and total replacement of the extensively deteriorated columns and floor boards. Some dismantling of the porch was necessary.*

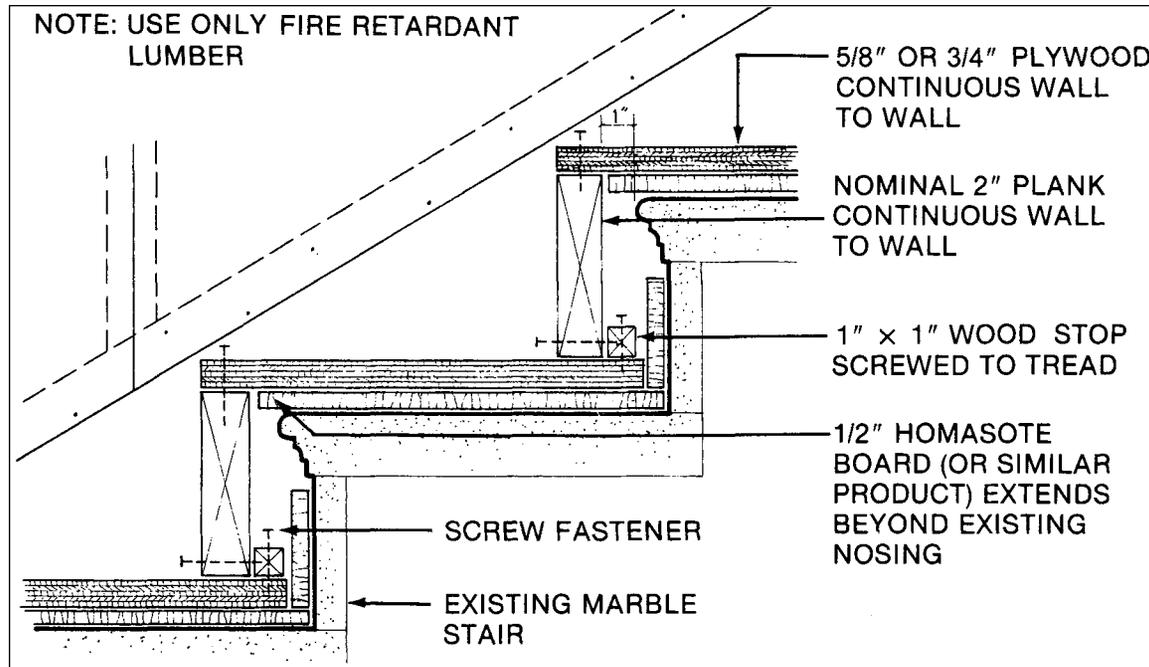
*Historic features that characterize a building should always be protected from damage during rehabilitation work. The drawing shows how a resilient, temporary stair covering was applied over the existing marble staircase. Drawing: National Park Service staff, based on material originally prepared by Emery Roth and Sons, P.C.*

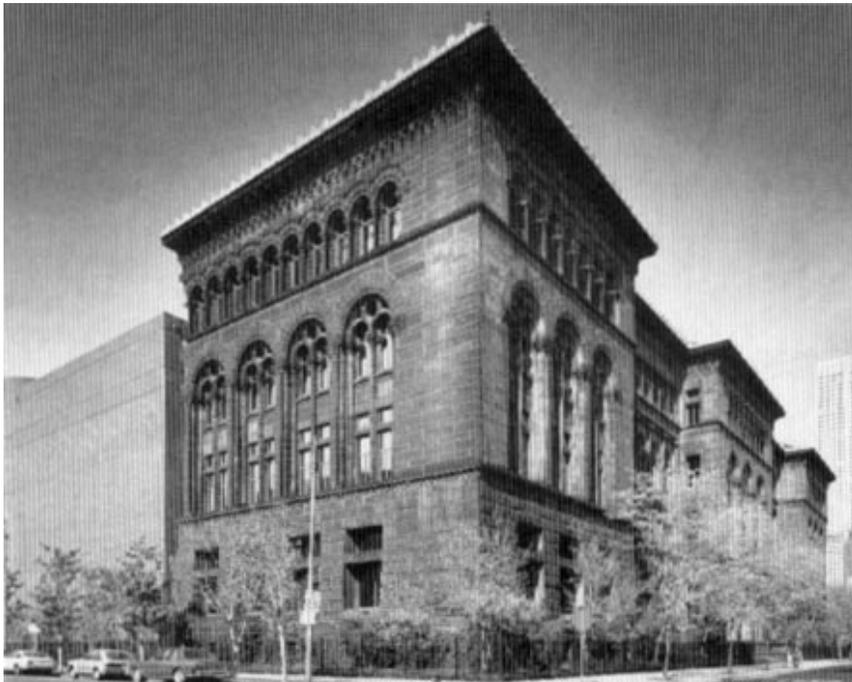
*Rehabilitation, like Preservation, acknowledges a building's change over time; the retention and repair of existing historic materials and features is thus always recommended. However, unlike Preservation, the dual goal of Rehabilitation is to—respectfully—add to or alter a building in order to meet new use requirements. This downtown Chicago library was expanded in 1981 when additional space was required with light and humidity control for the rare book collection. The compatible 10-story wing was linked to the historic block on side and rear elevations. Its simple design is compatible with the historic form, features, and detailing; old and new are clearly differentiated. Photo: Dave Clifton.*

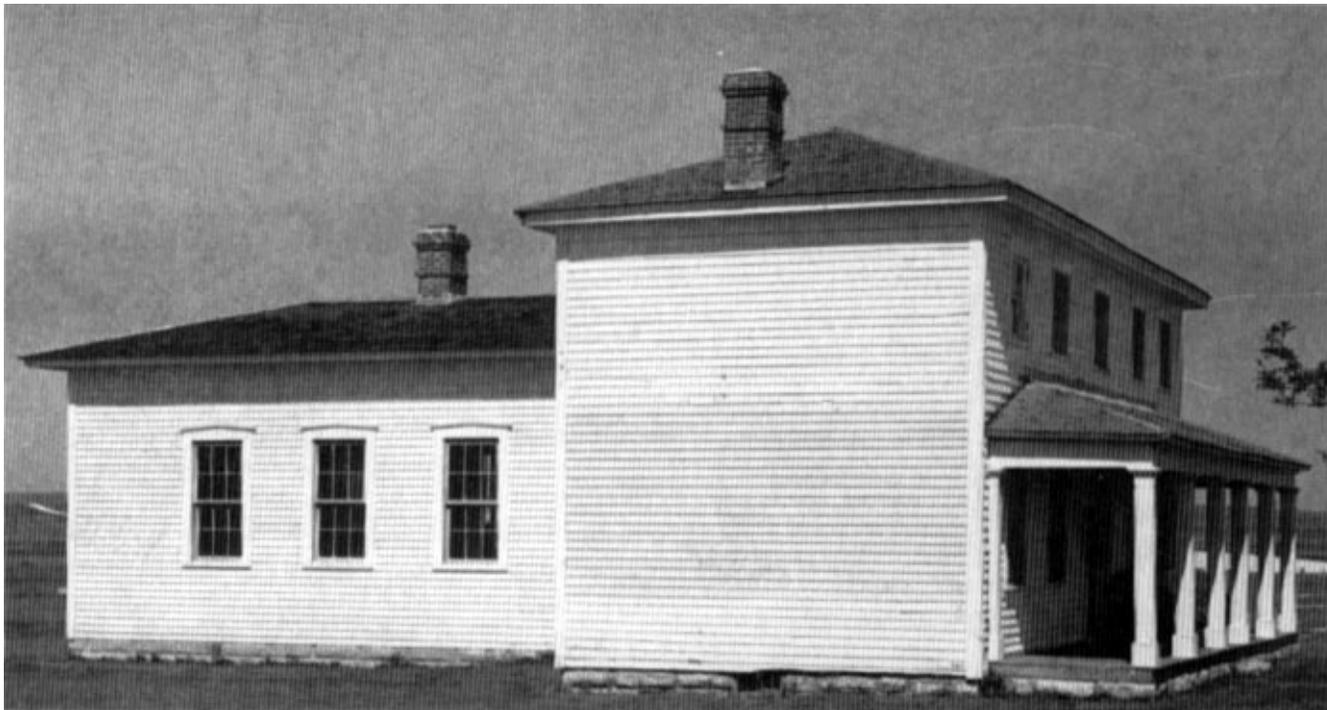
*In a project at Fort Hays, Kansas, the wood frame officers' quarters were restored to the late 1860s—their period of significance. This included replacing a missing kitchen ell, chimneys, porch columns, and cornice, and closing a later window opening in the main block. The building and others in the museum complex is used to interpret frontier history.*

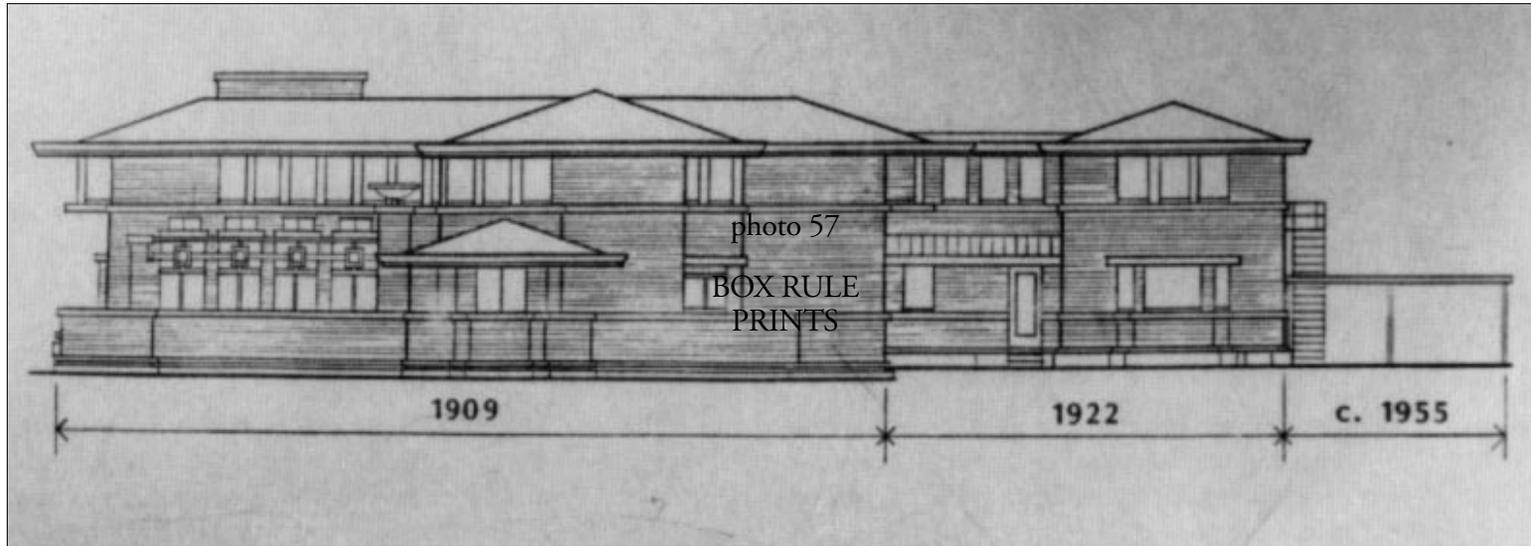
*The Meyer May House in Grand Rapids, Michigan, was designed by Frank Lloyd Wright and built in 1909. In 1922, May added to the house for an expanding family. After the May occupancy, the house was altered for use as apartments, with a carport added in 1955. In the 1980s restoration, the Wright's original design was deemed more significant than May's later changes, and, as a result, the additions were removed and the house returned to its 1909 appearance. Drawing: Martha L. Werenfels, AIA.*

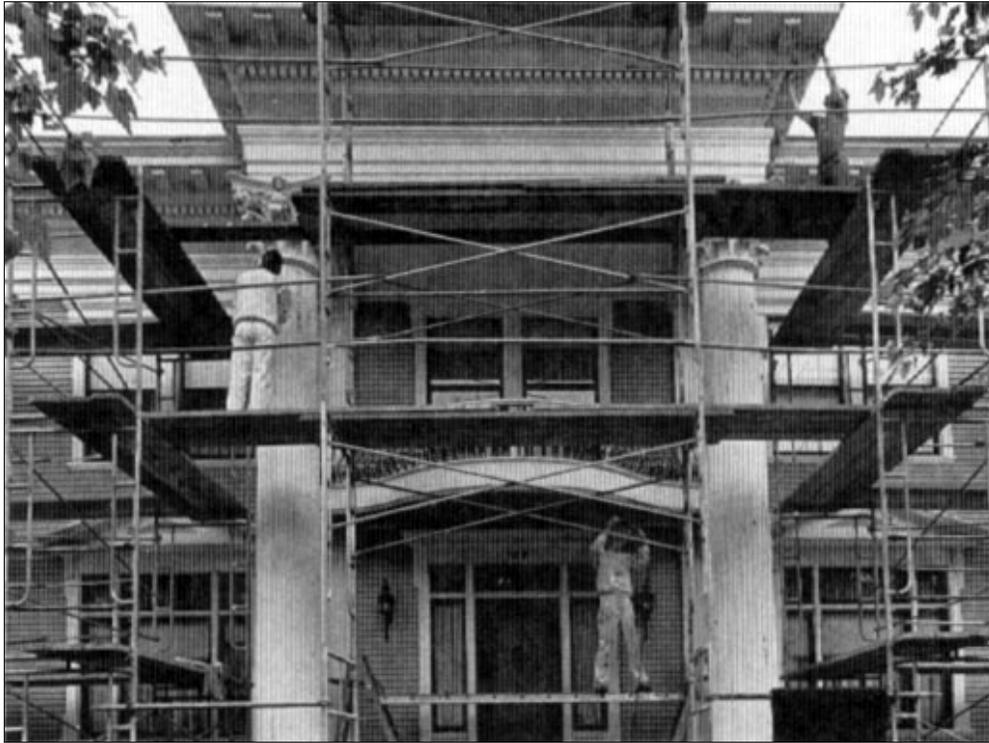
*Ongoing work at this house focuses on the maintenance and repair of exterior wood features from the restoration period. After scraping and sanding, the wood was painted in colors documented to the Restoration period. Photo: ©Mary Randlett, 1992.*

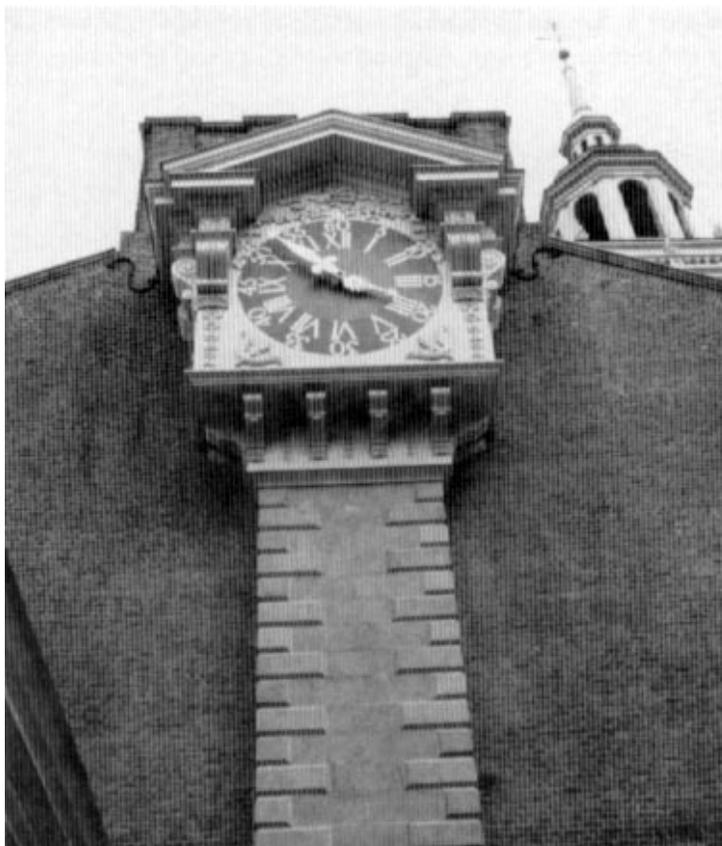
*The Standards for Restoration call for the repair of existing features from the restoration period as well as the re-creation of missing features from the period. In some instances, when missing features are replaced, substitute materials may be considered if they convey the appearance of the historic materials. In this example at Philadelphia's Independence Hall, the clock was re-built in 1972-73 using cast stone and wood with fiberglass and polyester bronze ornamentation. Photo: Lee H. Nelson, FAIA.*

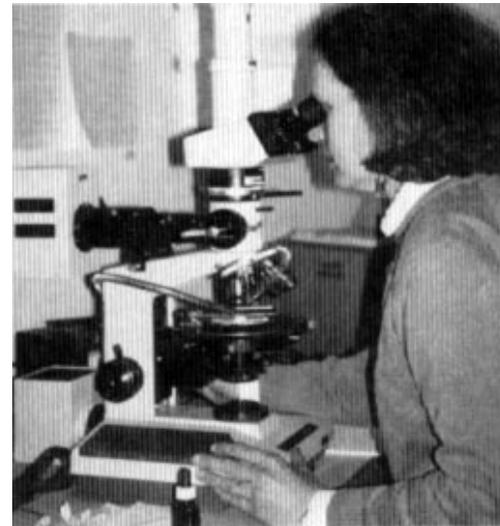
*A complete paint investigation often needs to be conducted during Restoration. Paint samples are carefully collected onsite. In the laboratory, an ultra violet light is used to identify pigment and binding media. Paint samples are then photographed. Physical evidence documented through laboratory research provides a sound basis for an accurate restoration of painted finishes, such as the complex stencilling pictured here. Photo left: Courtesy, Alexis Elza; Photo right: Courtesy, Andrea Gilmore.*

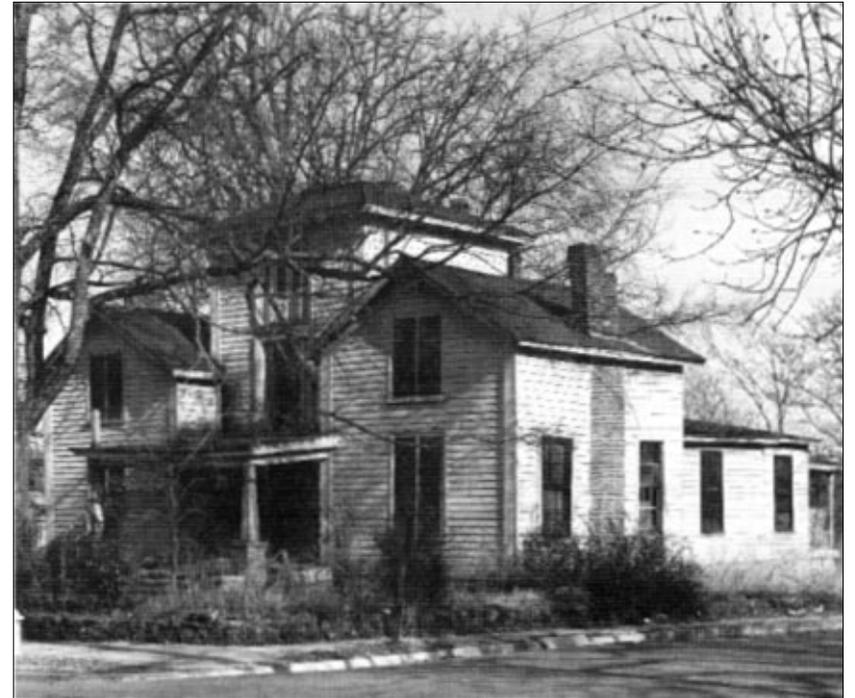
*This ca. 1900 photograph (left) would be invaluable to guide restoration of the deteriorated house (right) to its documented earlier appearance, complete with decorative trim, shutters, polychromed exterior, and fencing. Photos: Courtesy, North Carolina Department of Archives and History.*

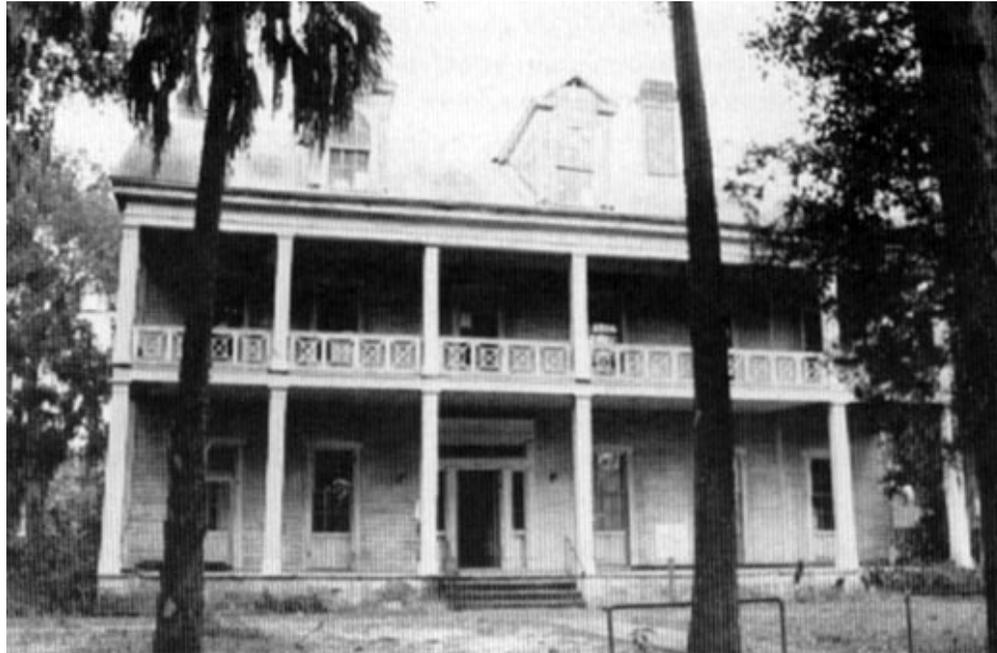
*The Bronson-Mulholland House in Palatka, Florida, ca. 1845, is shown (a) before and (b) after the treatment, Restoration. Over the years the east (far right) side of the veranda had been filled in as a sixth bay. During the restoration, this later infill was removed and the east veranda, together with its flooring, stairs, and foundation, restored. Photo: City of Palatka, Community Development Department.*

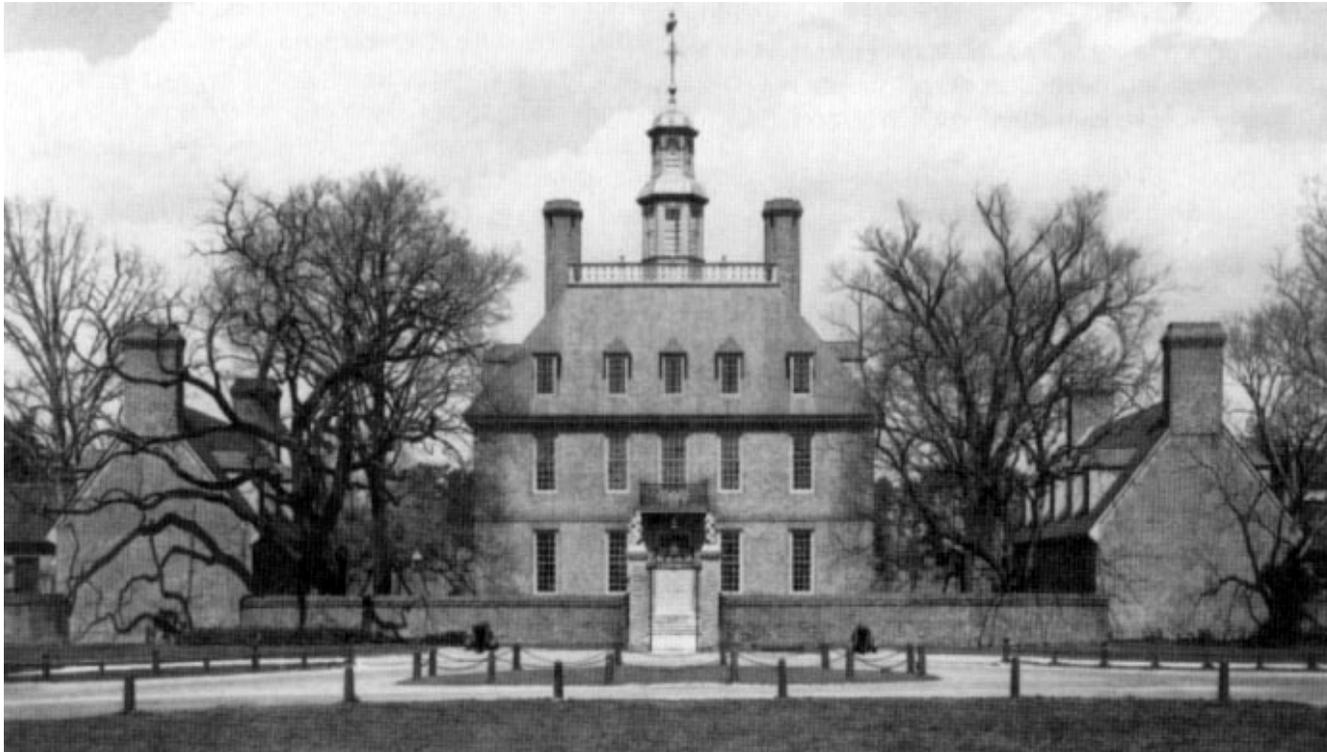
*In the 1930s reconstruction of the 18th century Governor's Palace at Colonial Williamsburg, Virginia, the archeological remains of the brick foundation were carefully preserved in situ, and serve as a base for the reconstructed walls.  
Photo: The Colonial Williamsburg Foundation.*

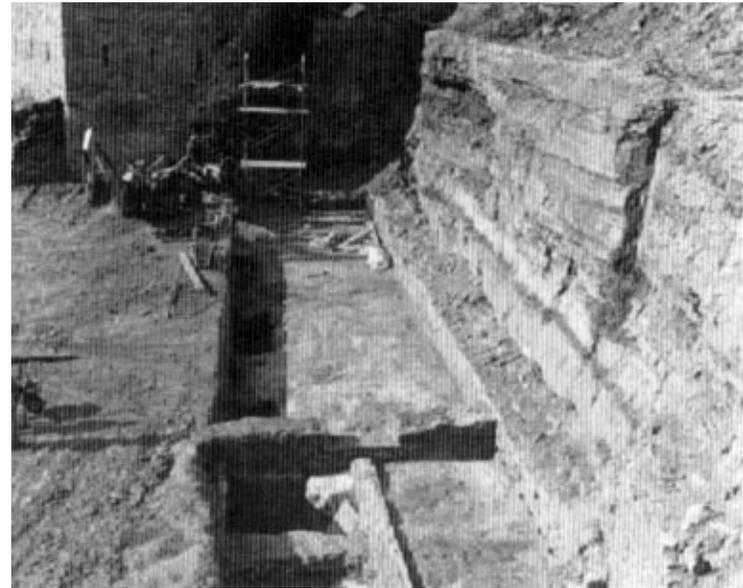
*Reconstruction should generally be based on an extensive archeological investigation, as was done here to re-create a non-surviving commissary building at Fort Snelling.*

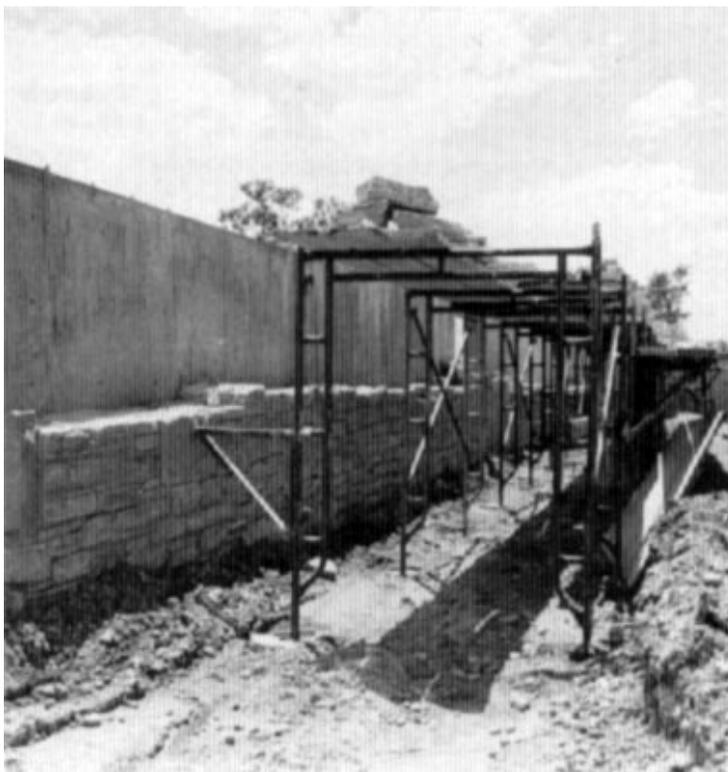
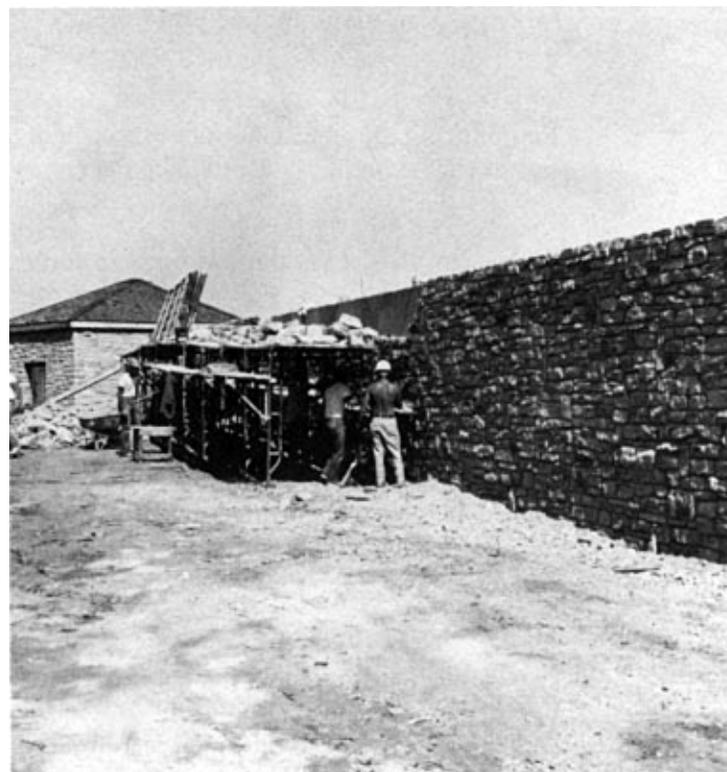
*(a) and (b). Two photos illustrate the use of contemporary construction materials and techniques within the treatment, Reconstruction. Because Reconstruction is employed to portray a significant earlier time, usually for interpretive purposes, substitute materials may be appropriate if they are able to convey the historic appearance.*

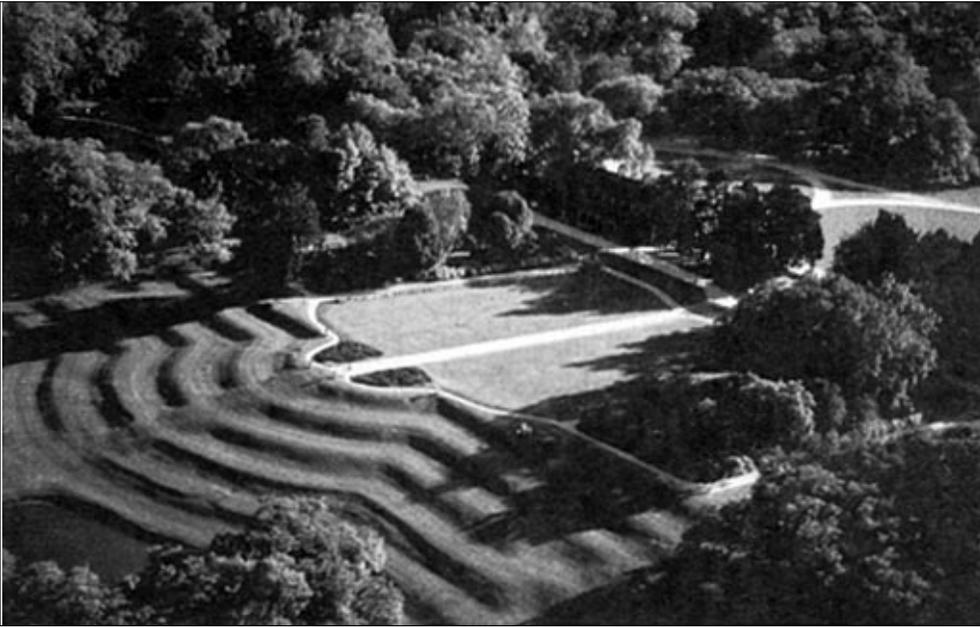
*The spacious grounds at Middleton Place, near Charleston, South Carolina, constitute the first landscaped garden in America. The molded terraces, originally constructed in the 18th century, were largely reconstructed in the early 20th century based on extant remains and other documentary evidence. Photo: Middleton Place.*

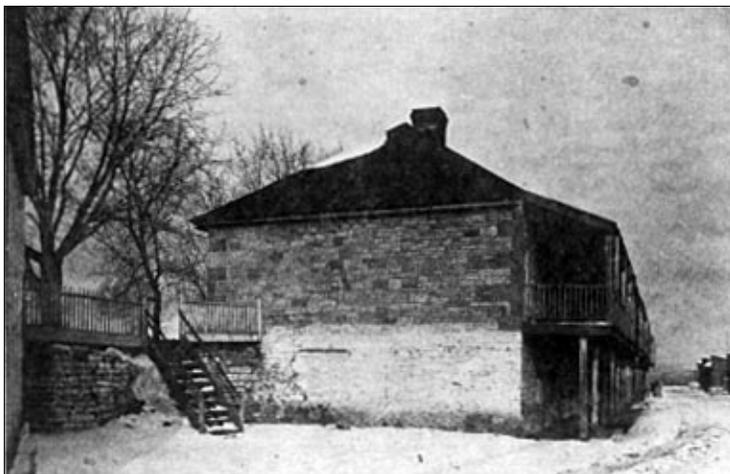
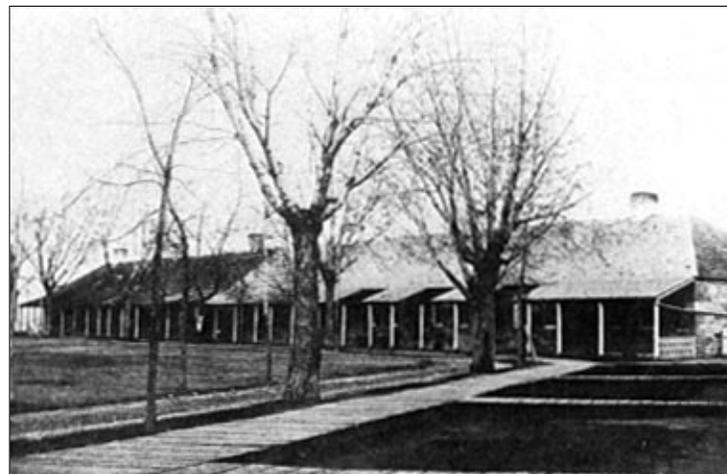
*(a) and (b). Two views of the Officers' Quarters at Fort Snelling (ca. 1885 to 1900) not only provide information on the materials and form of the historic block, they document the wooden walkways and other landscape features such as stairs, railings, and tree placement. Historical and pictorial evidence would need to be combined with specific physical evidence in order to make the case for Reconstruction as a treatment.*

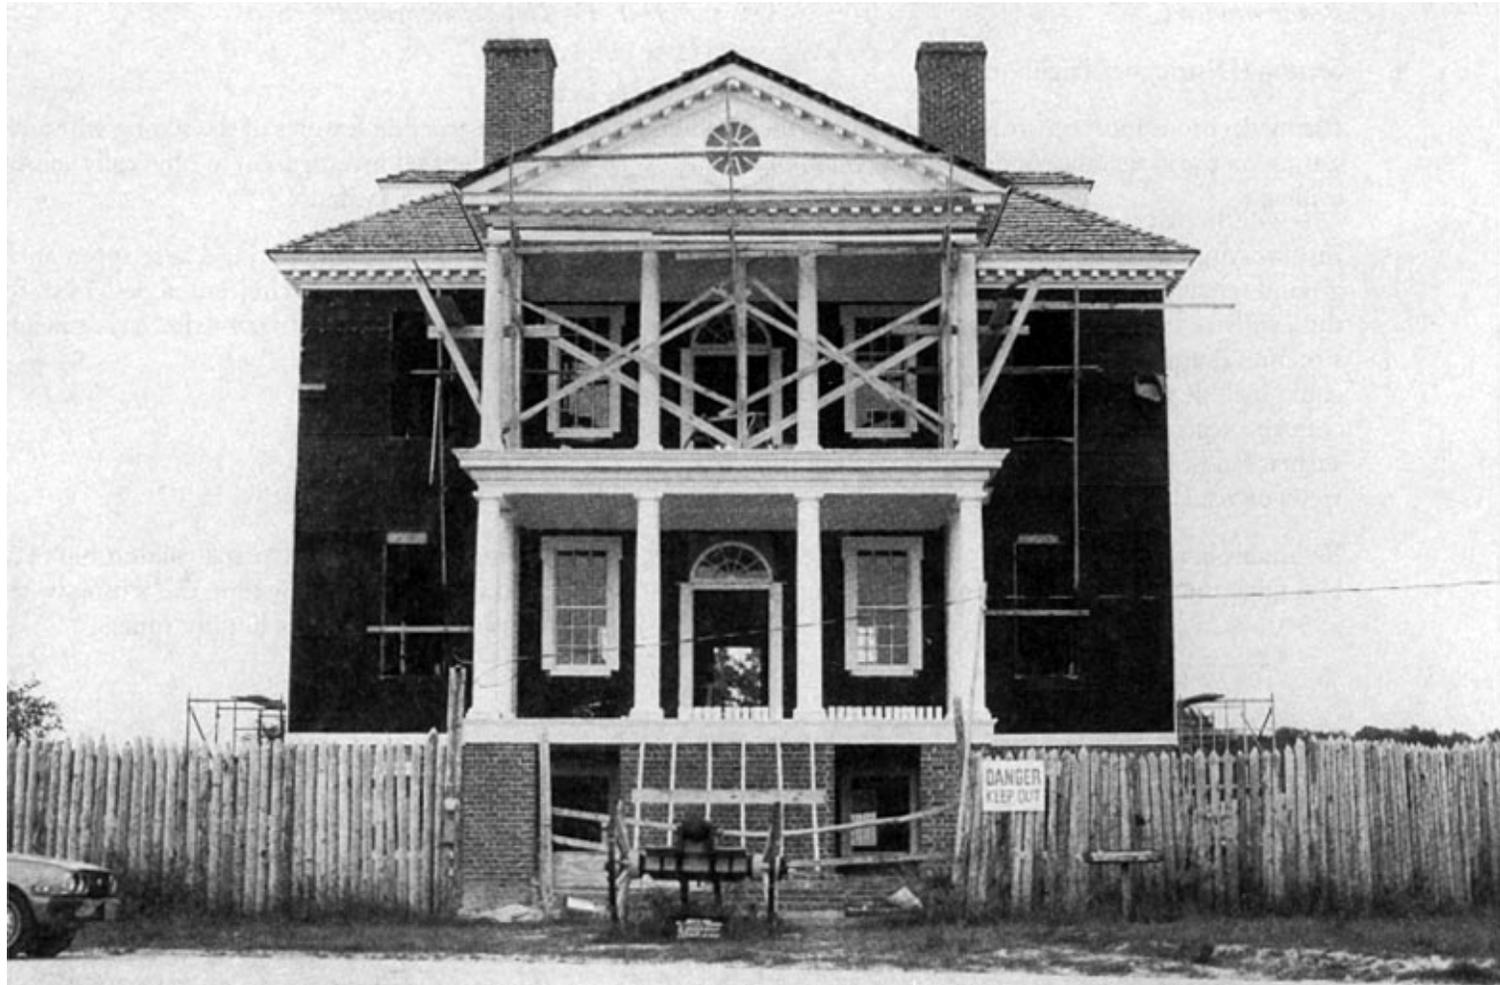
*The 1778 Kershaw House, which served as British Headquarters during the Revolutionary War, was burned by Union troops in 1865. In the early 1970s, the house was reconstructed as part of Camden Battlefield, Camden, South Carolina. Built expressly for interpretive purposes, it serves as an illustrative reminder of a past event of national significance. The Standards for Reconstruction call for any re-created building to be clearly identified as a contemporary depiction. This is most often done by means of an exterior sign or plaque, or through an explanatory brochure or exhibit. A guide may inform visitors as well. Photo: Richard Frear.*
